# Physical Processes and Natural Attenuation Alternatives for Remediation of White Phosphorus Contamination, Eagle River Flats, Fort Richardson, Alaska

Daniel E. Lawson, Lewis E. Hunter and Susan R. Bigl

**Abstract:** This report describes the results of investigations into the role of tidal flat physical systems in the natural attenuation of white phosphorus (WP) contamination in Eagle River Flats (ERF) on Fort Richardson, Alaska. Waterfowl feeding in ponds and marshes here ingest the WP and die. These investigations found that natural attenuation and in-situ degradation of the WP could result from certain physical phenomena operating within the ERF ecosystem. Specifically, the on-going erosion and headward recession in the gullies will drain large areas of contaminated ponds in an estimated 1 to 10 years. Lowering of water levels should lead to in-situ WP

CRREL Report 96-13

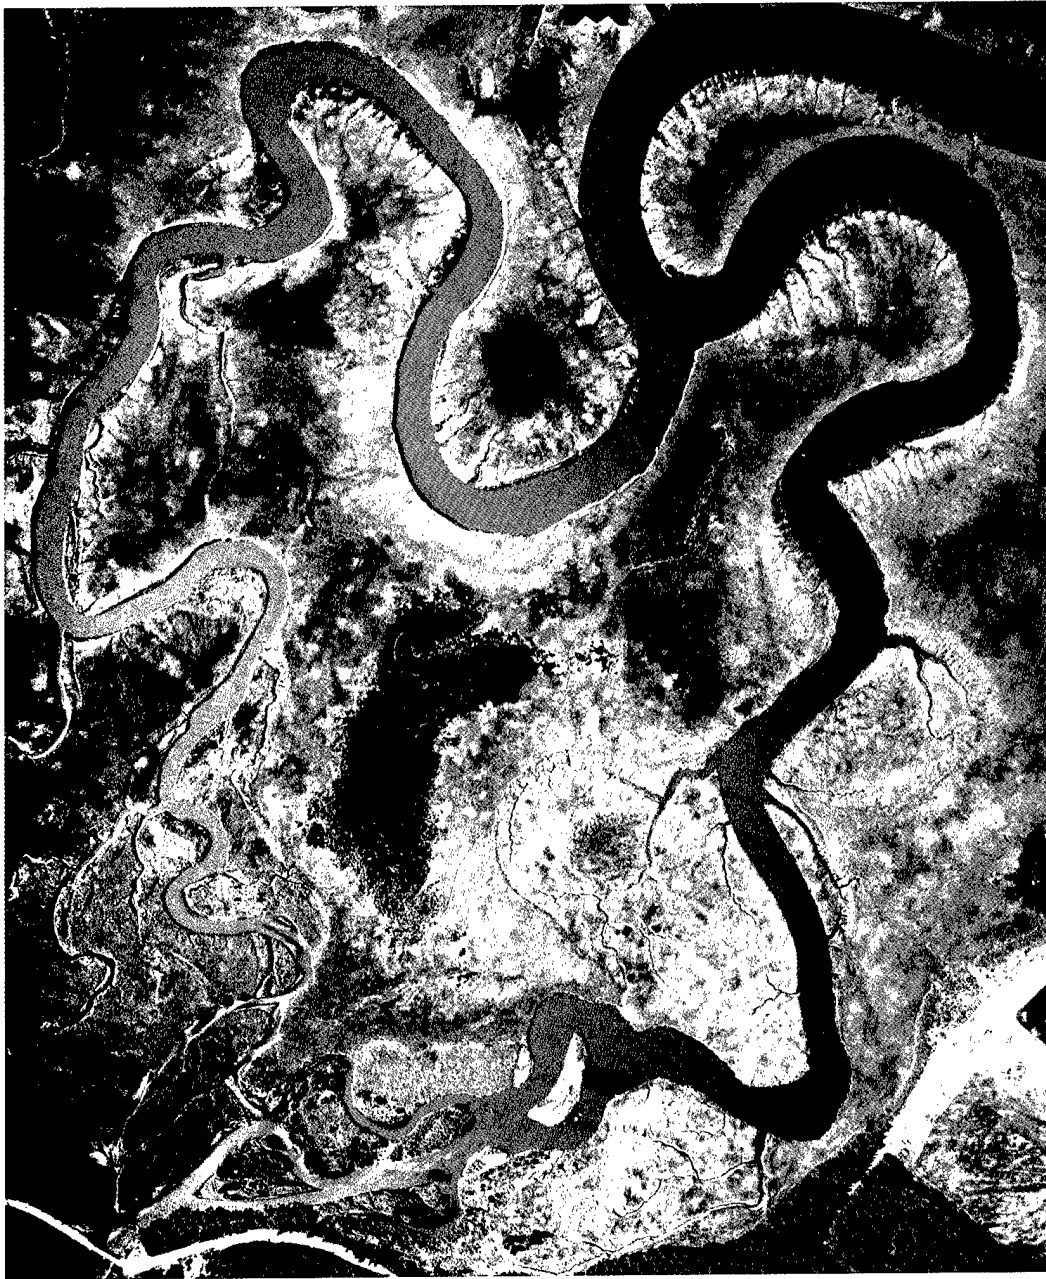
*Figure 6. Aerial photograph of Racine Island taken 16 August 1995 showing remnant channel surrounded by overbank deposits.*

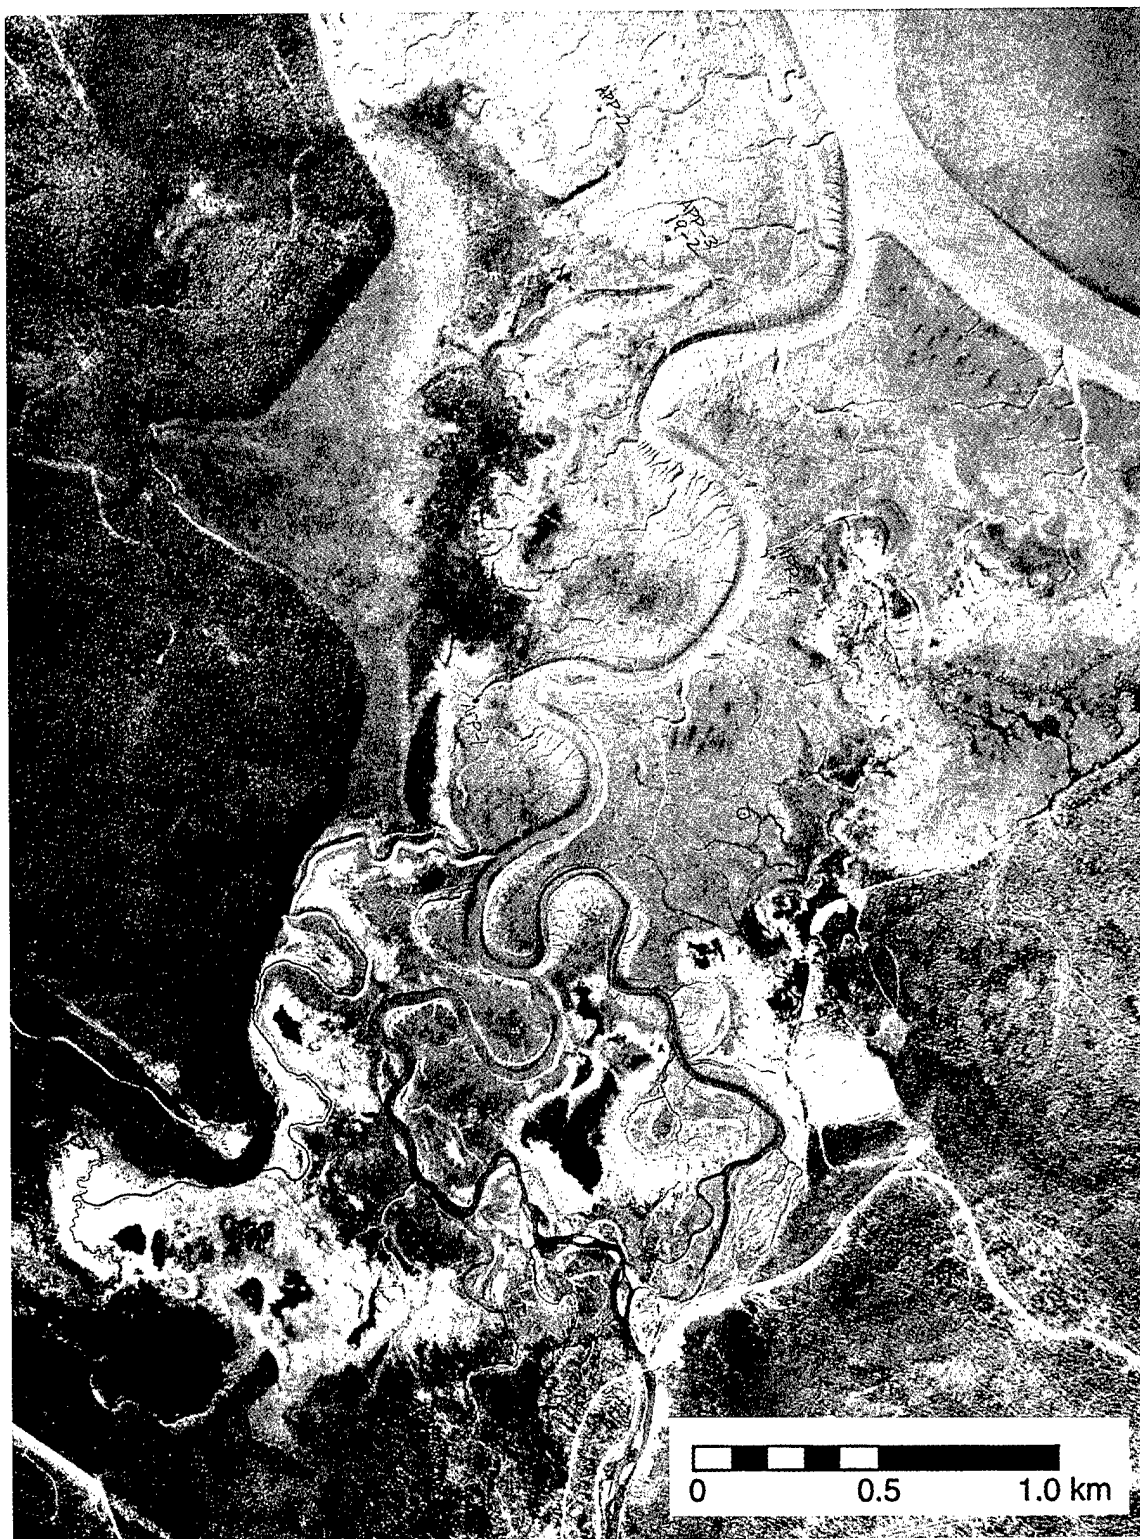
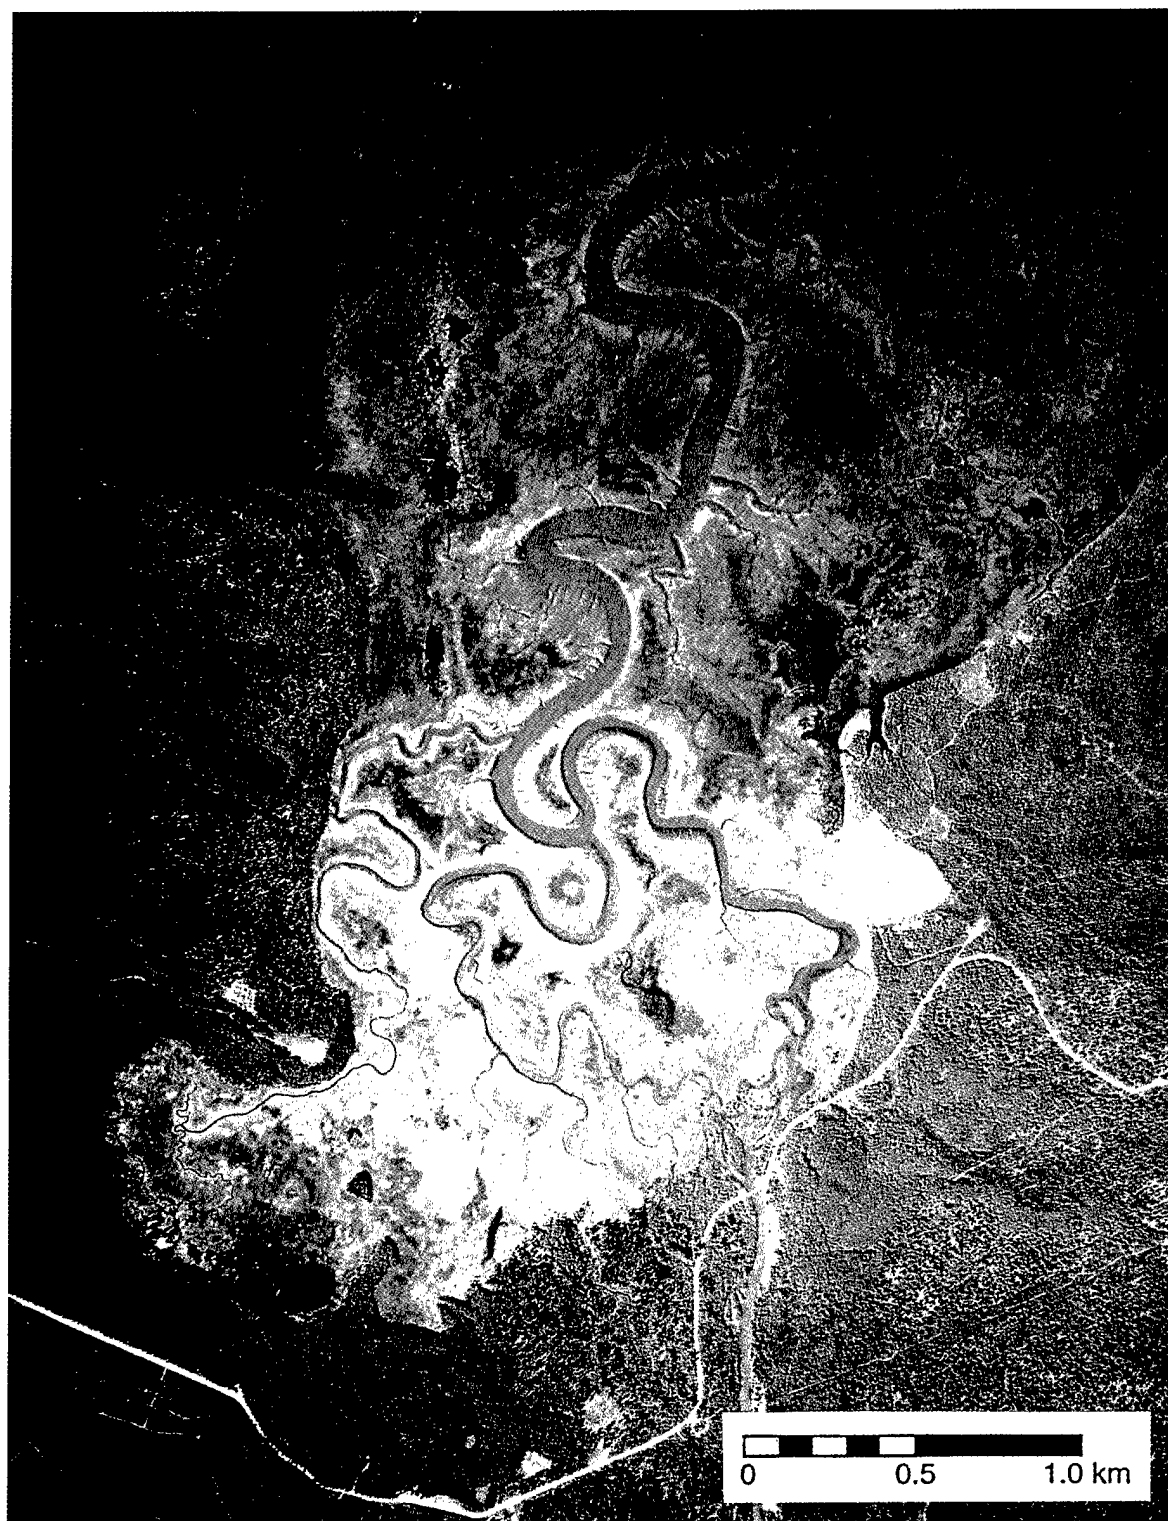
*Figure 7. Aerial photographs of ERF.*

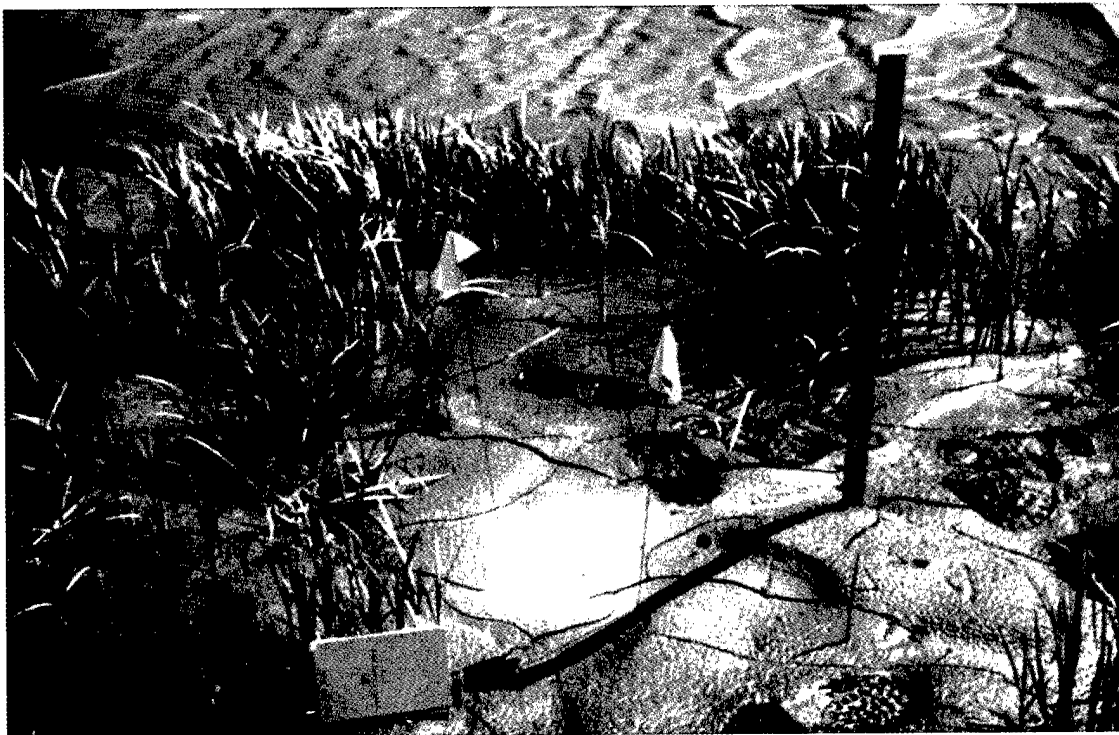
*a. Sedimentation stake with plate.*

*b. Wire flags mark an area of painted ground.*

*Figure 10. Sedimentation measurement techniques.*

Sedimentation on levee and mudflat surfaces was monitored by spraying an area (~30 × 30 cm) on the ground surface with pavement-marking paint and locating the corners of this area with wire survey flags (see also Vince and Snow 1984). Paint was applied at certain sites in June and August 1992, August 1993, and May–June 1994. Net accumulation was measured by cutting and removing a block of sediment with a putty knife or spatula (Fig. 11). The thickness of sediment above the paint layer was then measured to the nearest 0.5 mm. In contrast to the sedimentation stakes that were commonly broken or removed by ice during winter, the wire flags and buried paint horizons enabled us to acquire a continuous record of net sedimentation rates.

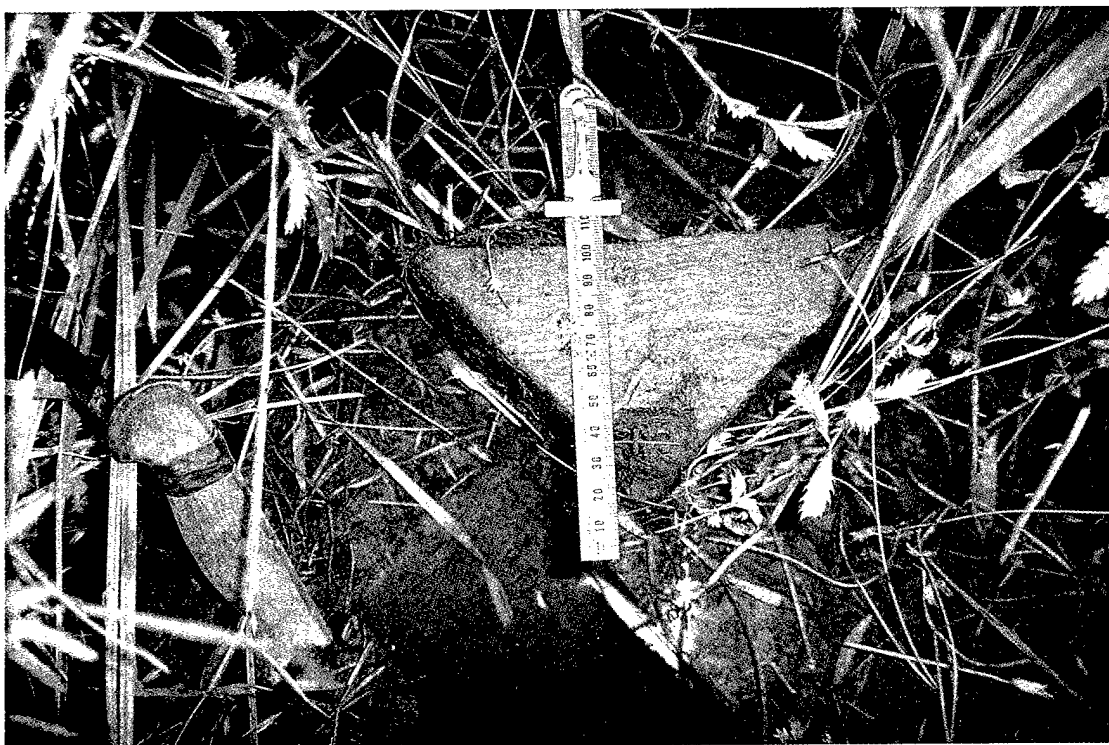
Figure 11. Wedge-shaped sediment block used to measure vertical accretion. Note subhorizontal laminations.

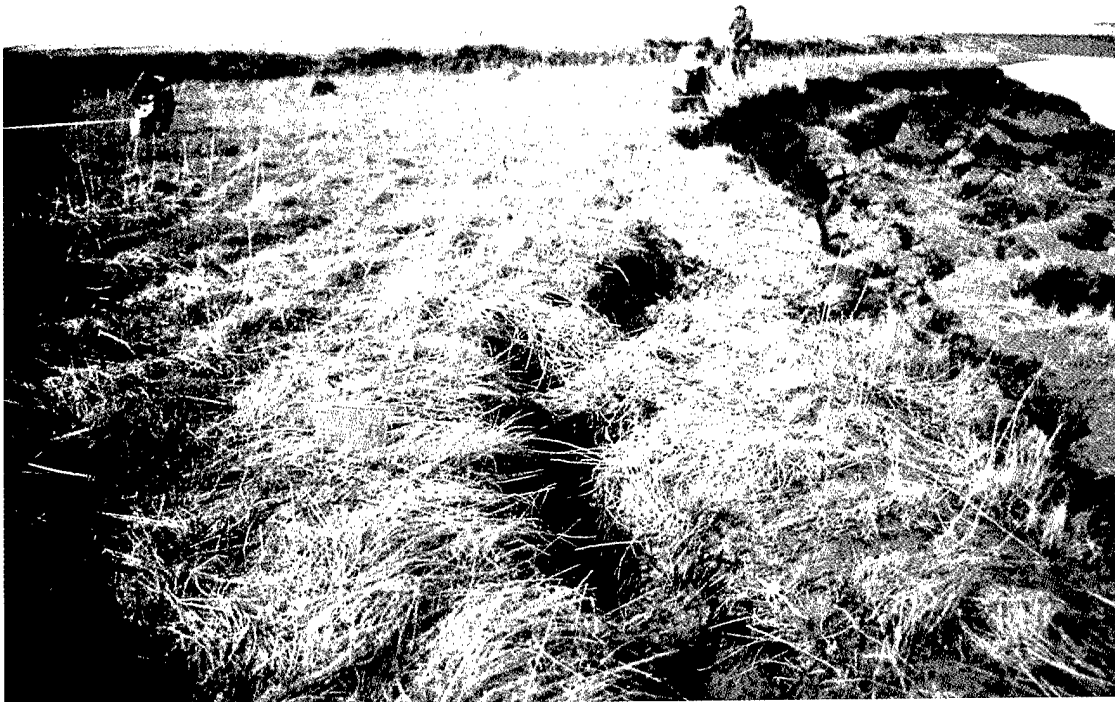
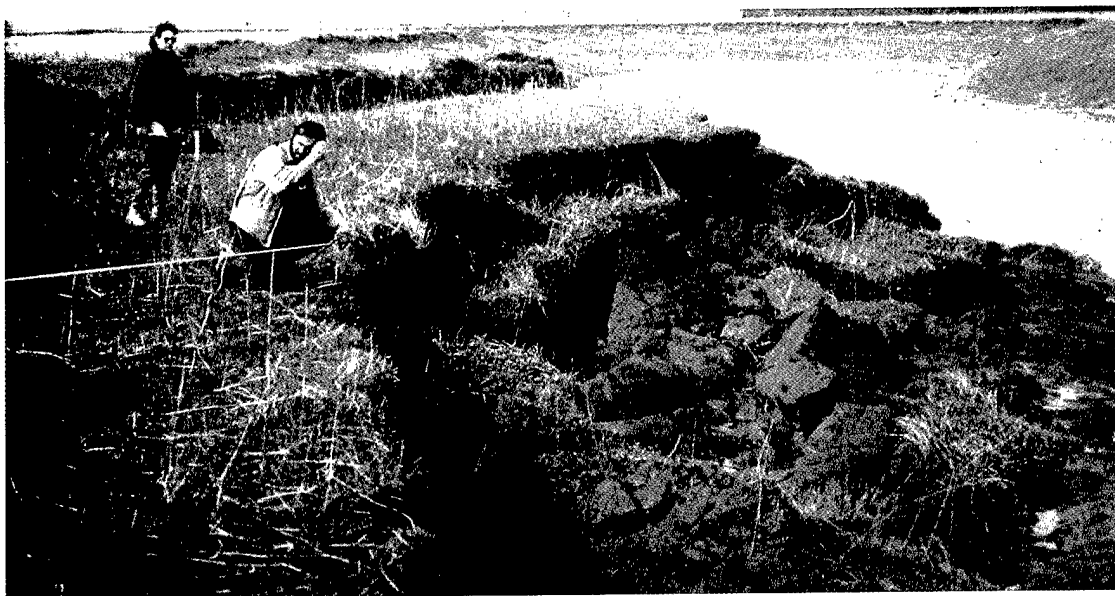
*a. North view showing extension crack in foreground.*

*b. Rotational slump blocks visible to right of scarp.*

early stage of collapse (Fig. 24). This extension was particularly evident in May of 1995 following the first tidal flooding cycle (15–17 May 1995) after thawing of the ground began. A shallow snow cover in the winter allowed frost to penetrate deeply. Intermittent flooding and subsequent pond drainage are favorable to ice growth (Fig. 25). The subsequent freezing of interstitial

Figure 23h shows one section of the monitoring network at the River-North site, where slope processes are consuming mudflat sediments and introducing material directly into the Eagle River (Fig. 24). Rapid lateral erosion on the order of 3.2 m was recorded at this site between July and November of 1994, and there was up to 7.4 m of recession by late October 1995. Erosion occurs along large rotational slumps that fail because of river undercutting and removal of sediment supporting the toe of the slope (Fig. 24b). Prior to failure, large extension cracks develop parallel to the scarp, gradually leading to catastrophic failure (Fig. 24a). The location of the crack becomes the new scarp of the riverbank.

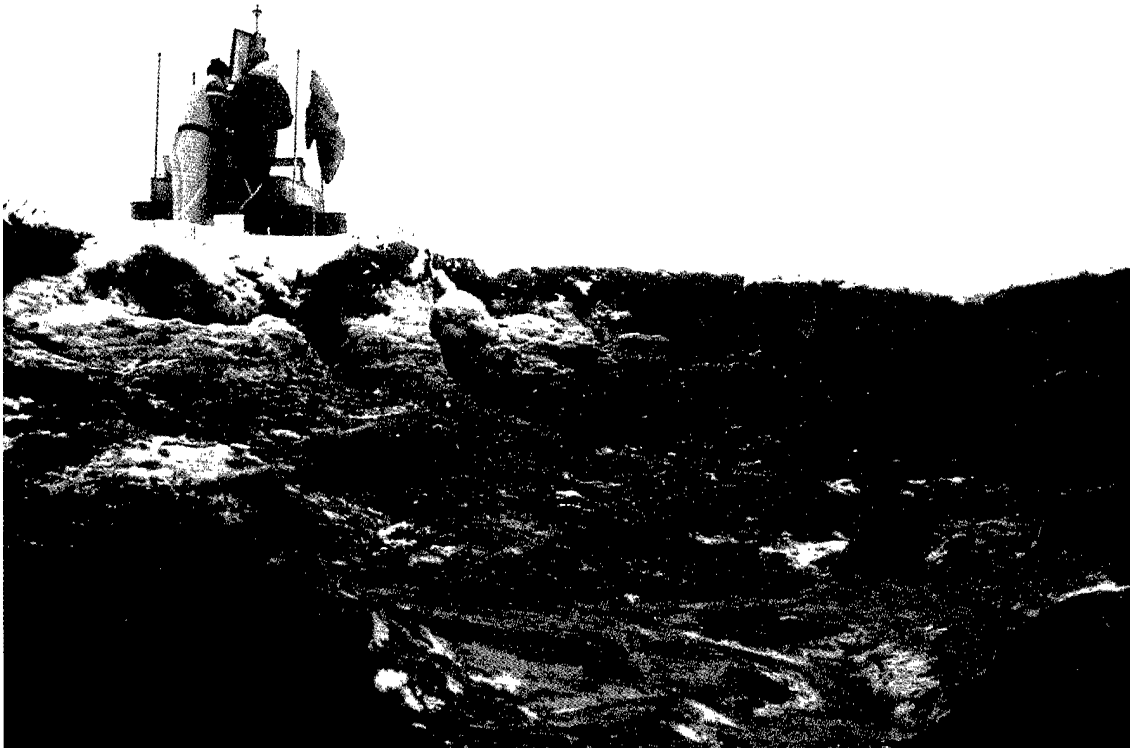
*a. Lateral wall view. Ice armor is caused by repeated flooding and subsequent freezing in gully.*

*b. Headwall view showing ice coating formed by freezeup of waters flowing into gully.*

*Figure 25. Bank of Bread Truck Gully showing ice growth formation.*

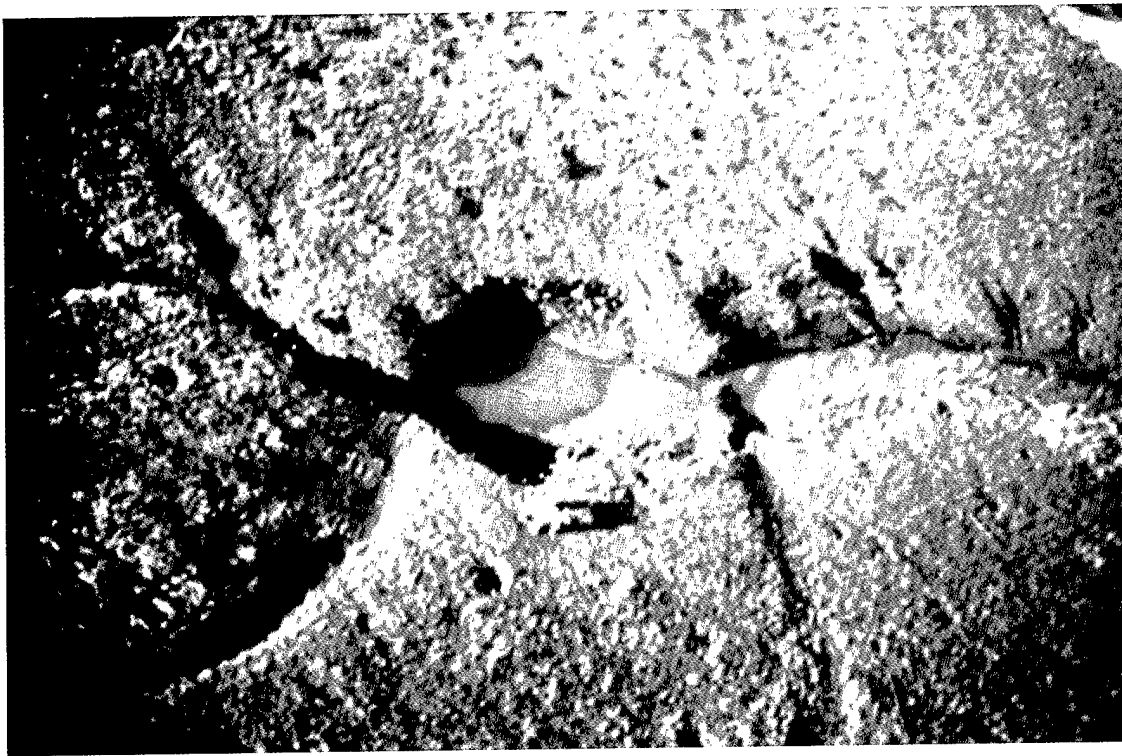
*Figure 26. Aerial view of Parachute Gully in October 1995 showing accelerated headward recession that has accompanied capture of flow through craters.*

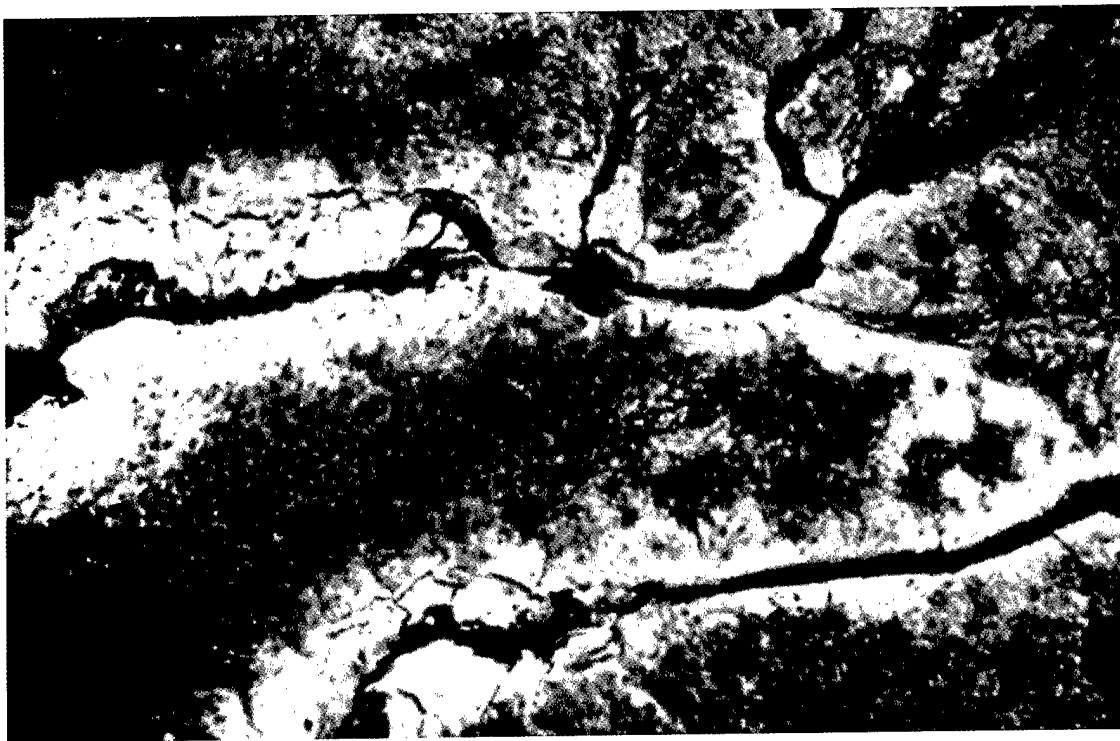
*a. Area A.*

*Figure 27. Aerial view of gullies where recession and ebb flow have been modified by surface craters.*

*b. B-Gully.*

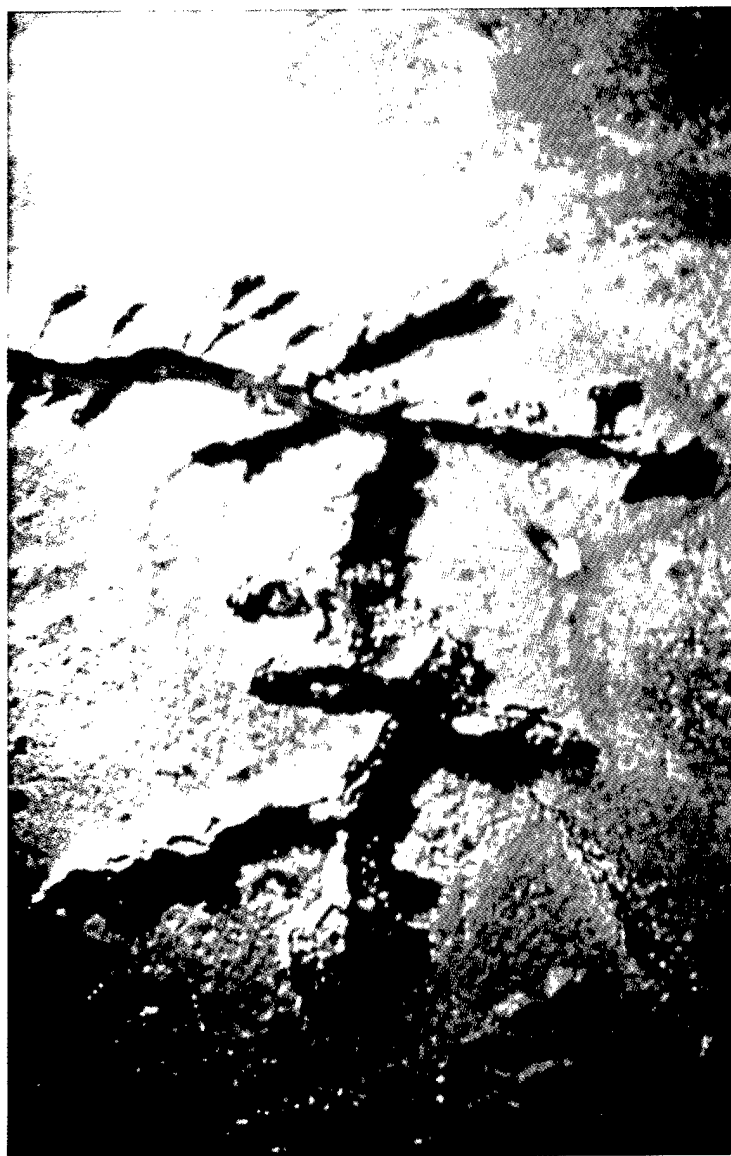
Figure 28. Aerial view of Bread Truck Gully in October 1995.

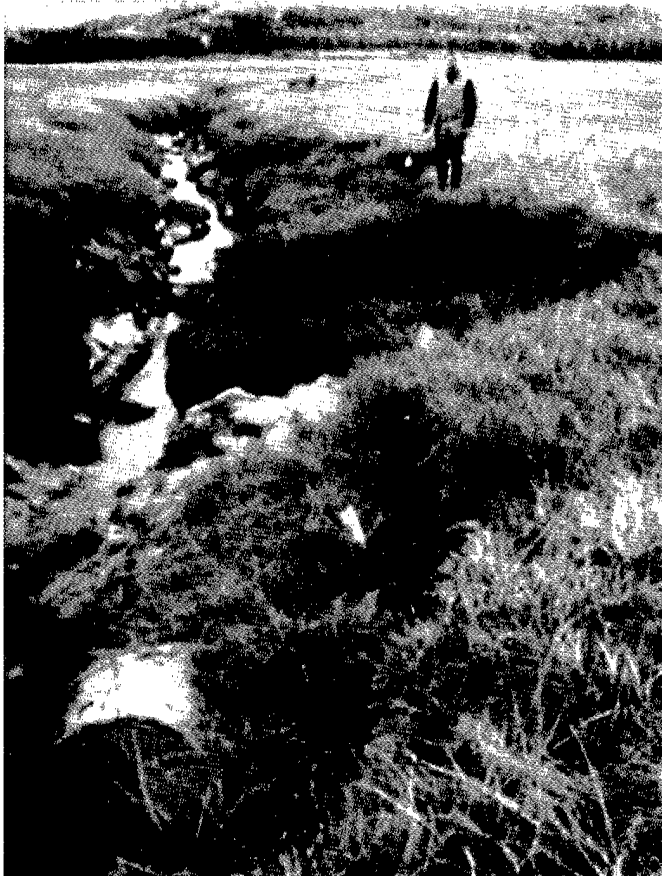
*Figure 29. Eastward view of eroding cusped embayments at B-Gully.*

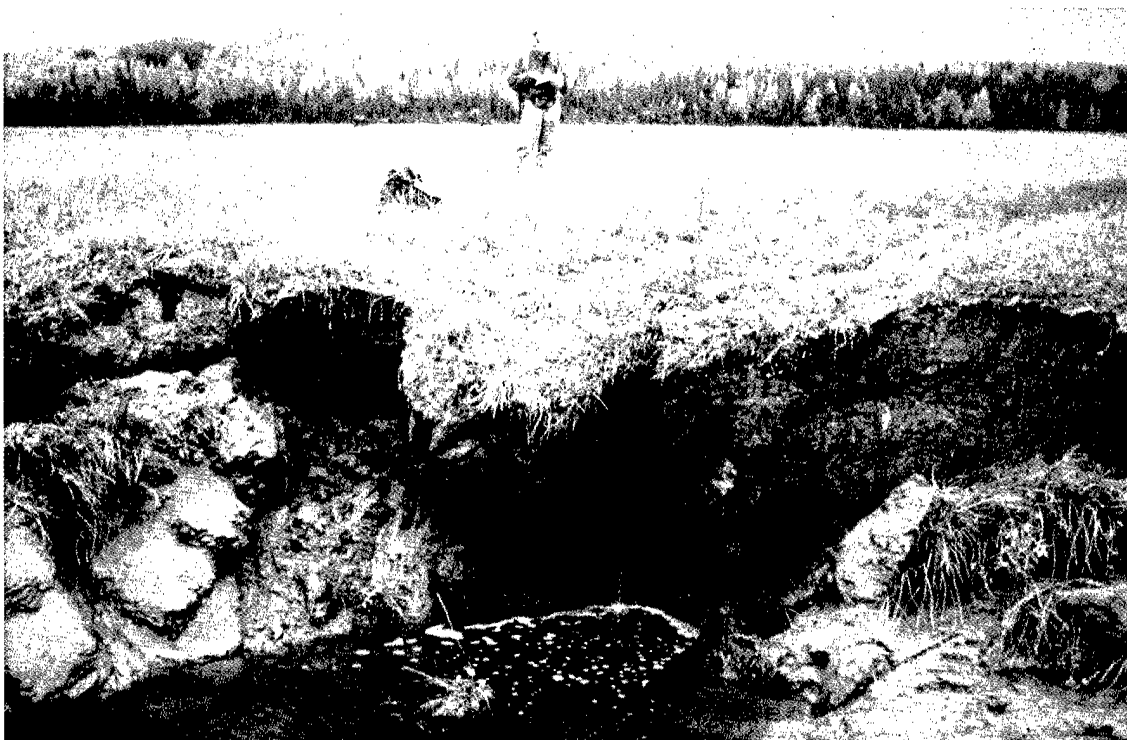
*Figure 30. Thick laminated peat layer at Coastal 6 forms the threshold to channel downcutting and headward recession.*

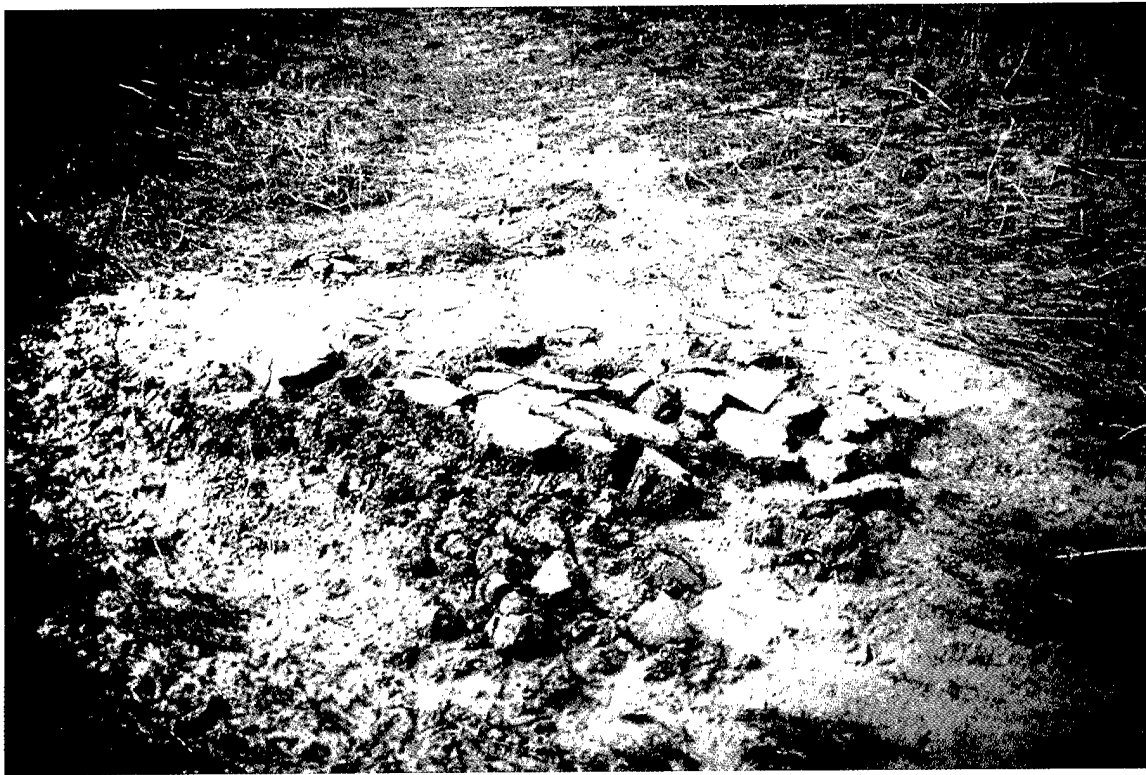
*a. Sediment layer frozen onto an ice block transported during the November 1994 flooding tides.*

*Figure 36. Ice rafting at ERF.*

*b. Ice-rafted sediment deposited at the head of Mortar Gully.*
